Friday 21.09 - Friday 28.09

Weekly report

Nikolay Anfimov, Week coordinator, JINR.

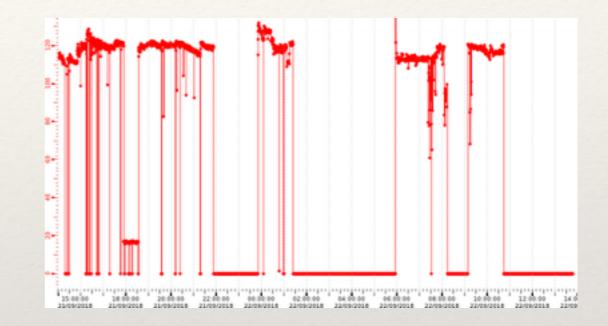
MP01MY_occupancies
- * Beam had gone around 10 pm and back at midnight
- Spikes in occupancies for Pixel MM (MP01MY)
