Weekly report W30/31

27 July – 3 August (2018-W08/W09)

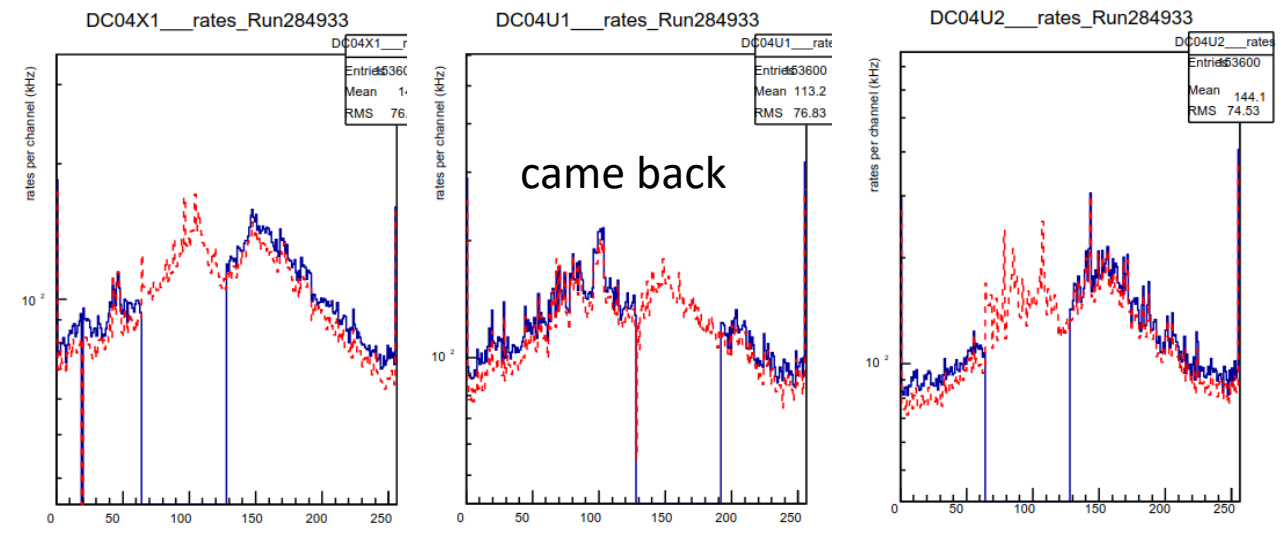
DC04

before intervention 01.08.

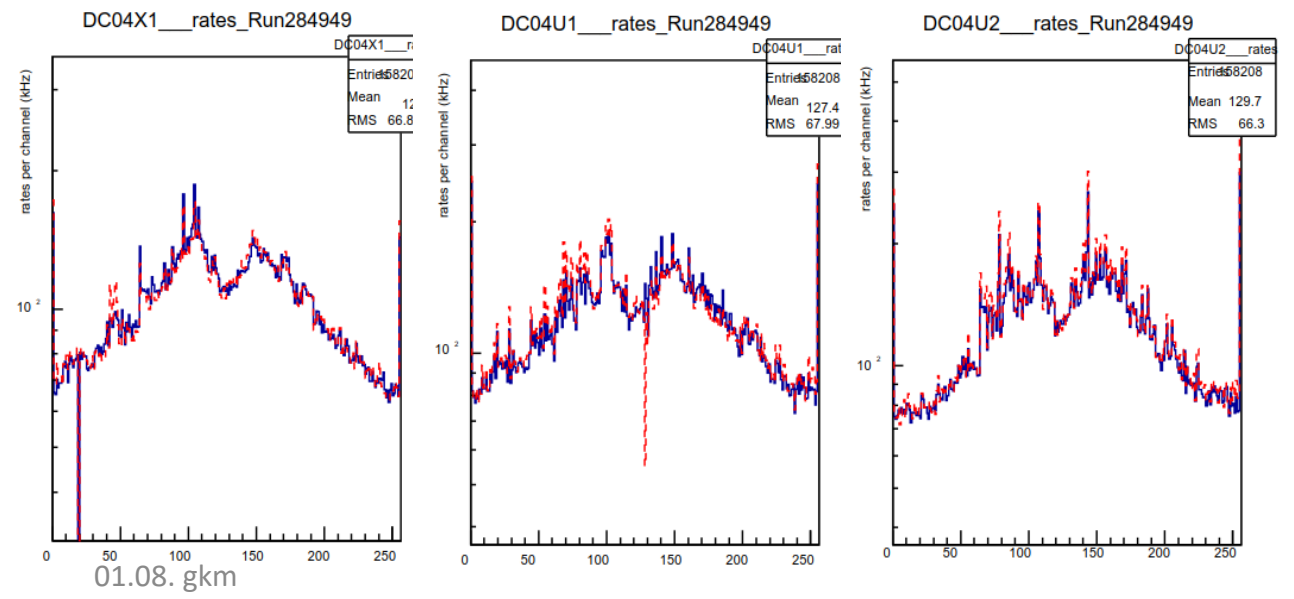
after intervention
DC04U1 problem came back

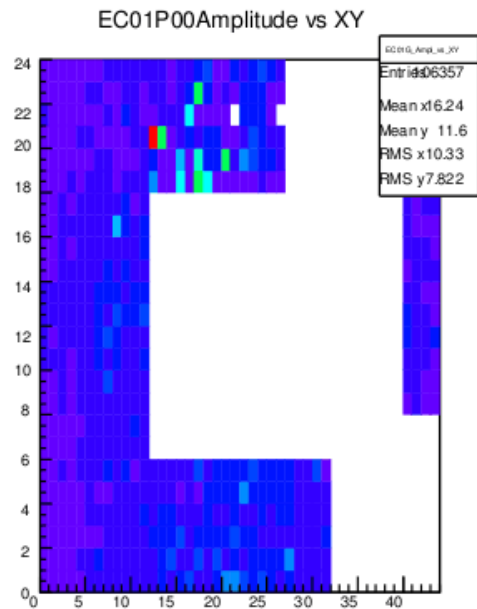
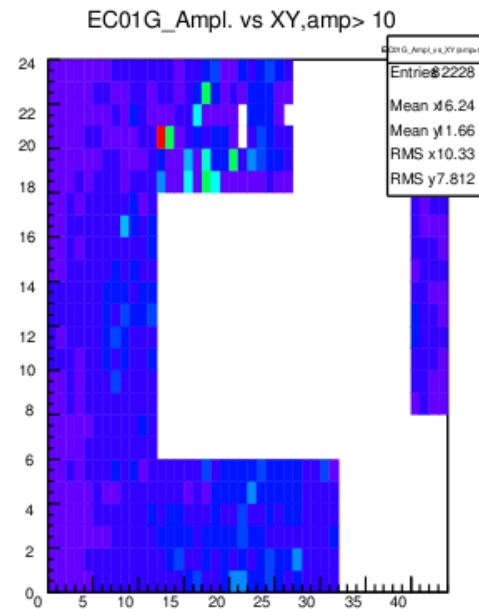
New problem: ECAL1

SourceID	Type	v BadEvents	#Header	#Data	#Errors	Special	Special at	#Spills	Last spill
626	ECAL	100.0%	0.00	0.00	1.00	1.00	330	8	8
886	DC05	0.5%	0.00	77.87	0.01	0.00	0	7	8
2	Master-T	0.3%	8.00	82.02	0.01	0.00	0	5	8
852	SciFi-15U	0.1%	24.00	23.92	0.00	0.00	0	2	8

since about 03.08. 00:00

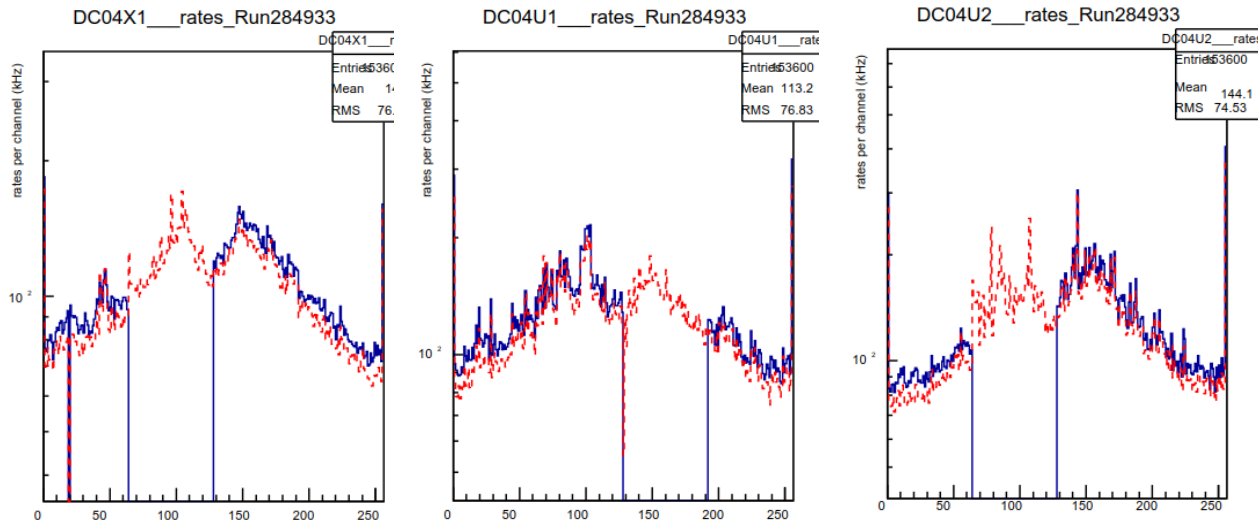
before intervention

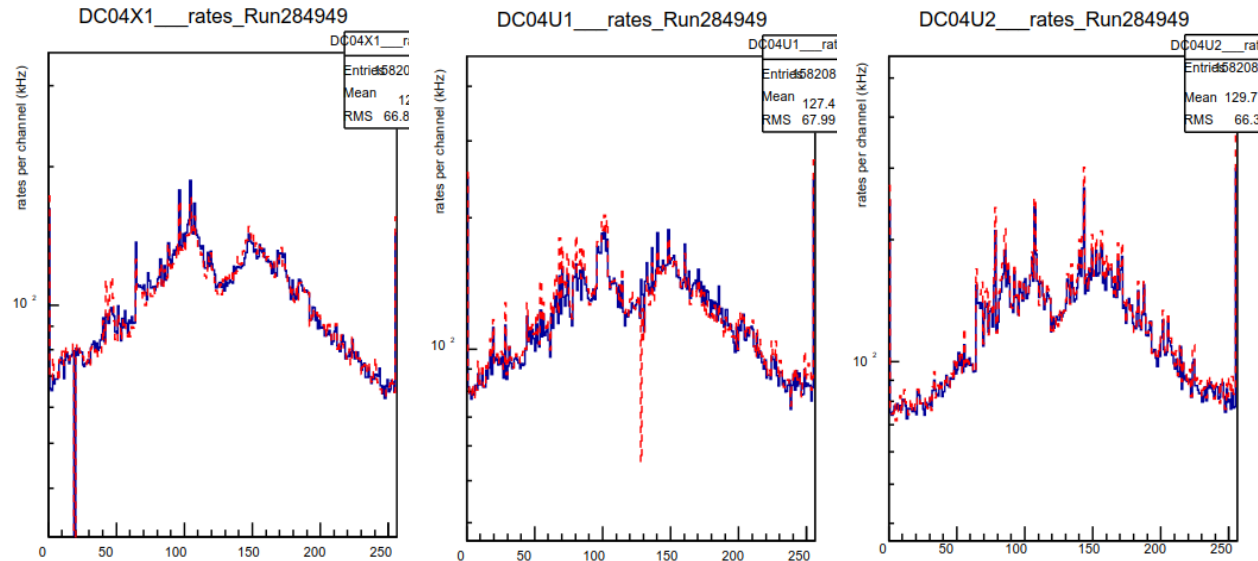
after intervention

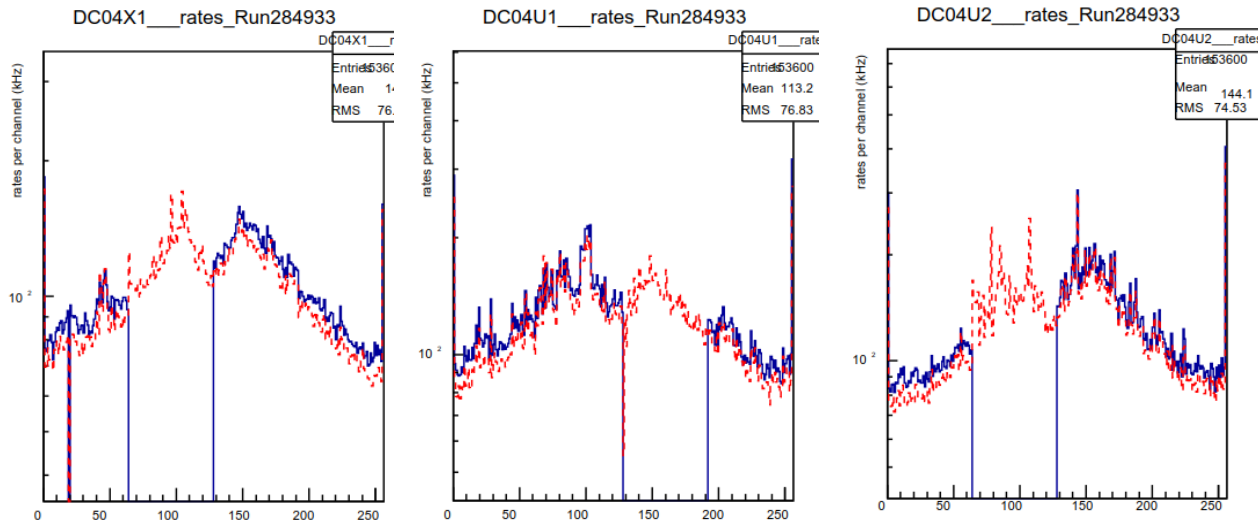
before intervention

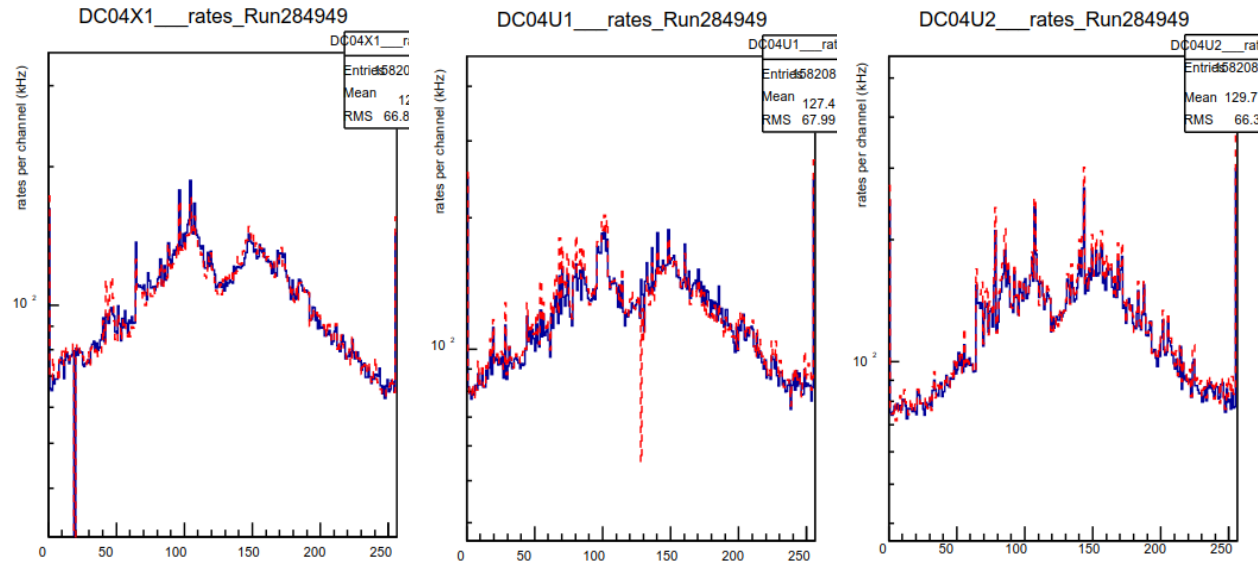
after intervention

- DC04: all ports recovered (cables)
- PMM: module 1 recovered (fuses), module 3 changed but still faulty
- RW: improved gas flow, some improvements, flow references to be adjusted
- GEM: pedestal run for all GEM and PGEMs, 2 spare ADCs validated
- Straw: threshold data taken
- PT: polarization measured: -71.7% upstream, $+76\%$ downstream
- Trigger: OT, MTLAS dead times measured, veto&trigger timing checked

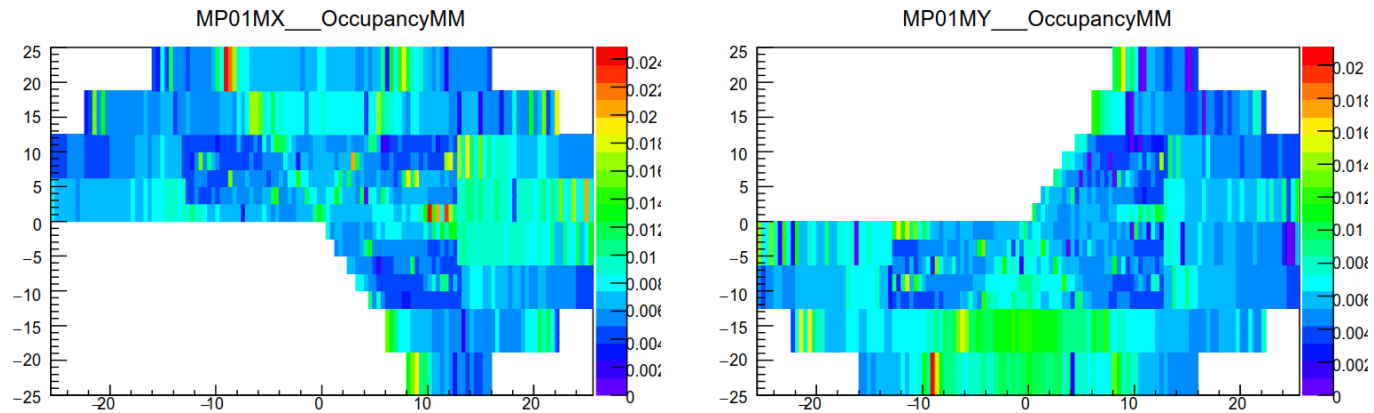
before intervention

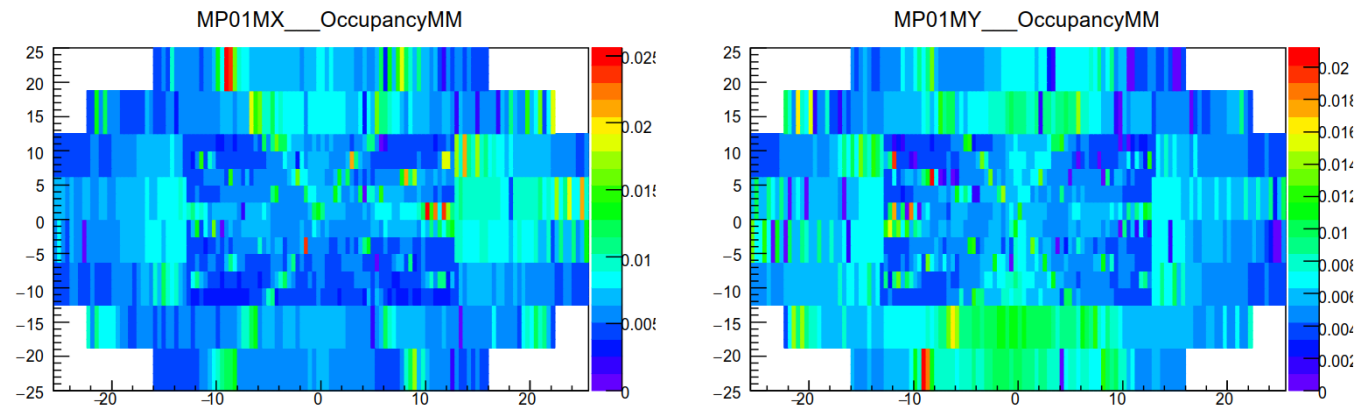
Good news PMM1

after intervention

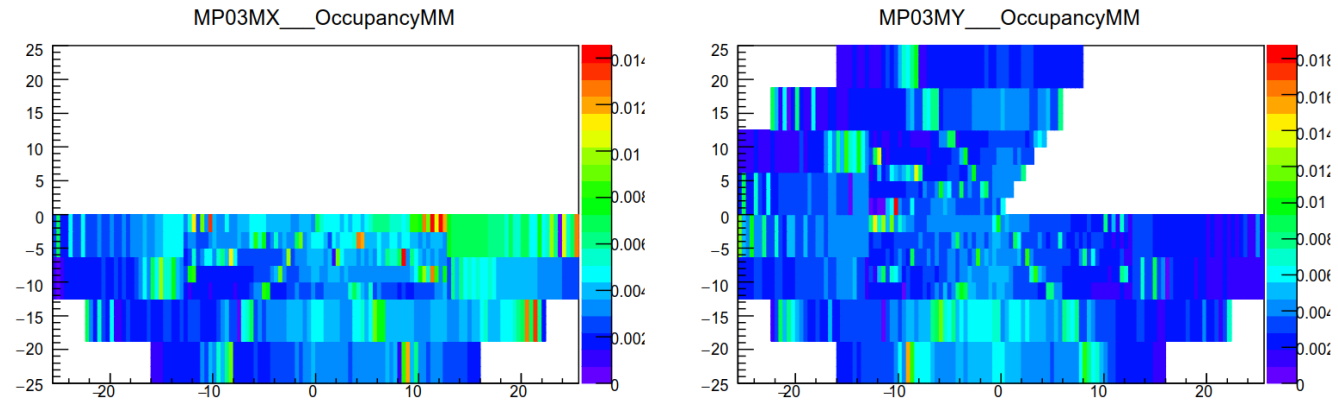
before intervention

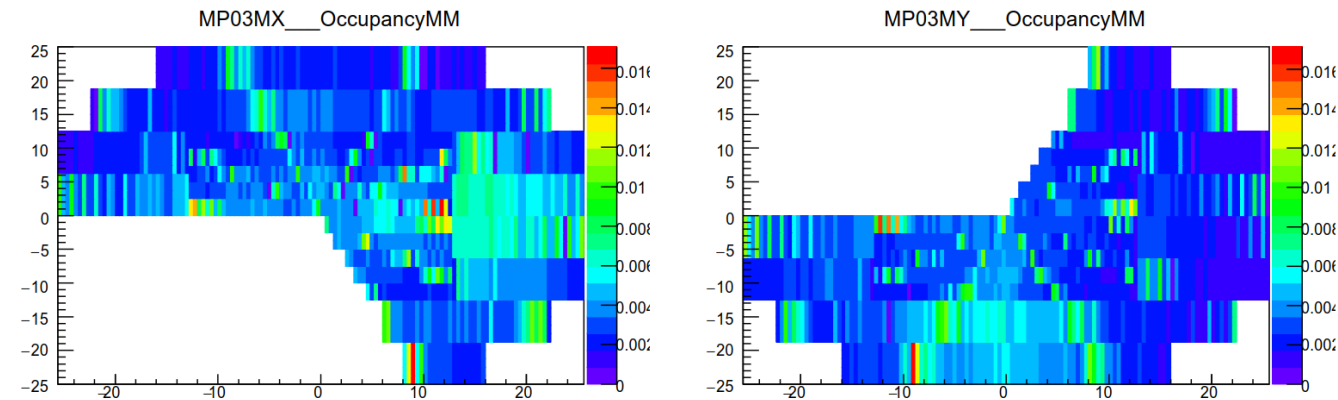
Not so good news PMM3

after intervention

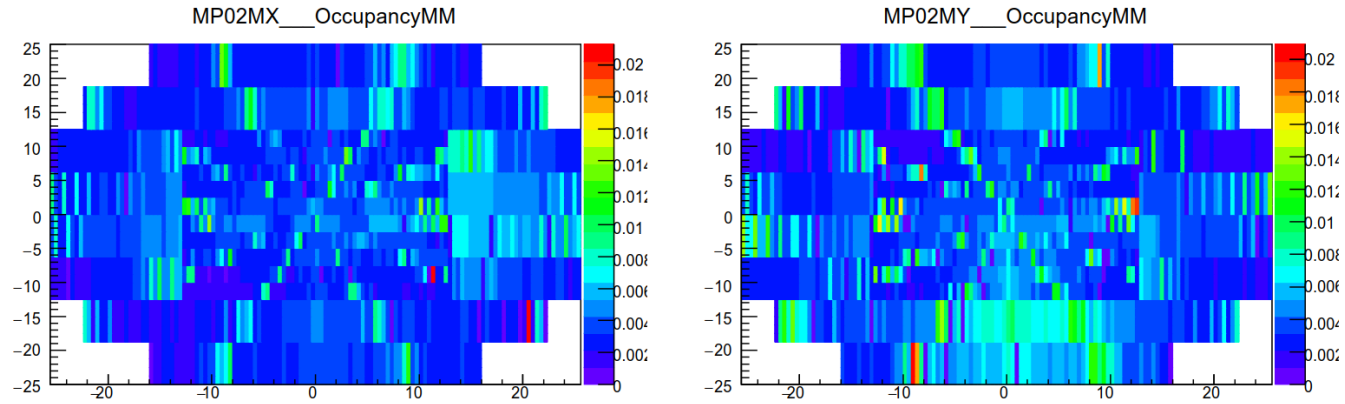
yesterday

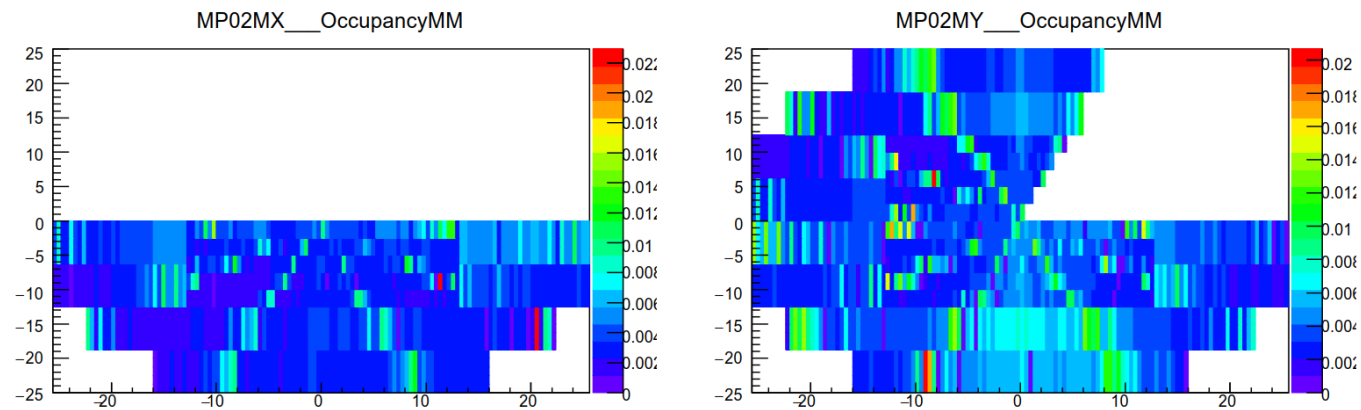
Bad news PMM2

now

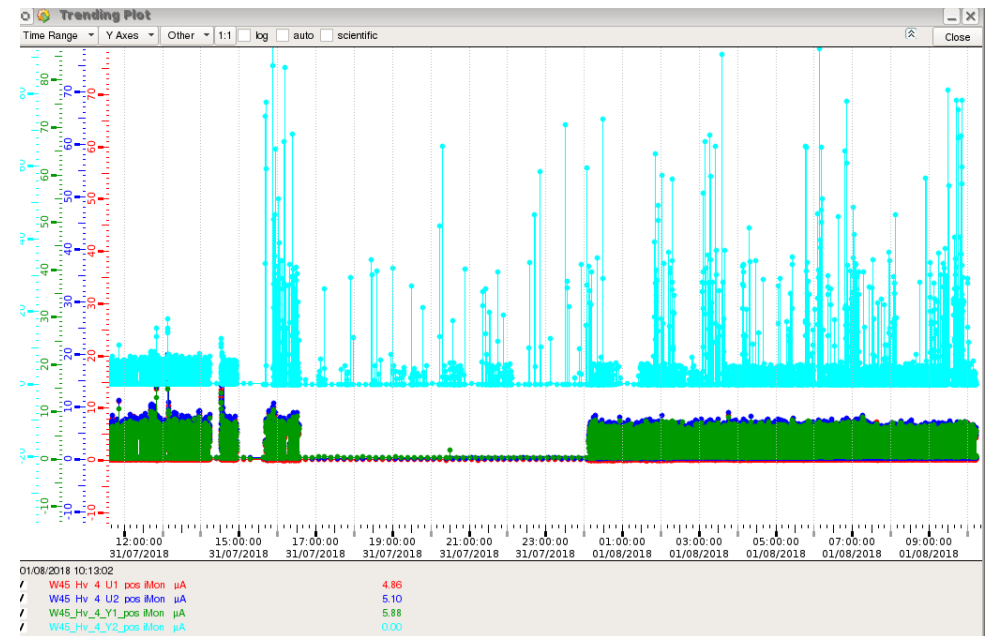
W45 maybe cured itself → check current DW04Y2 (cyan) and others

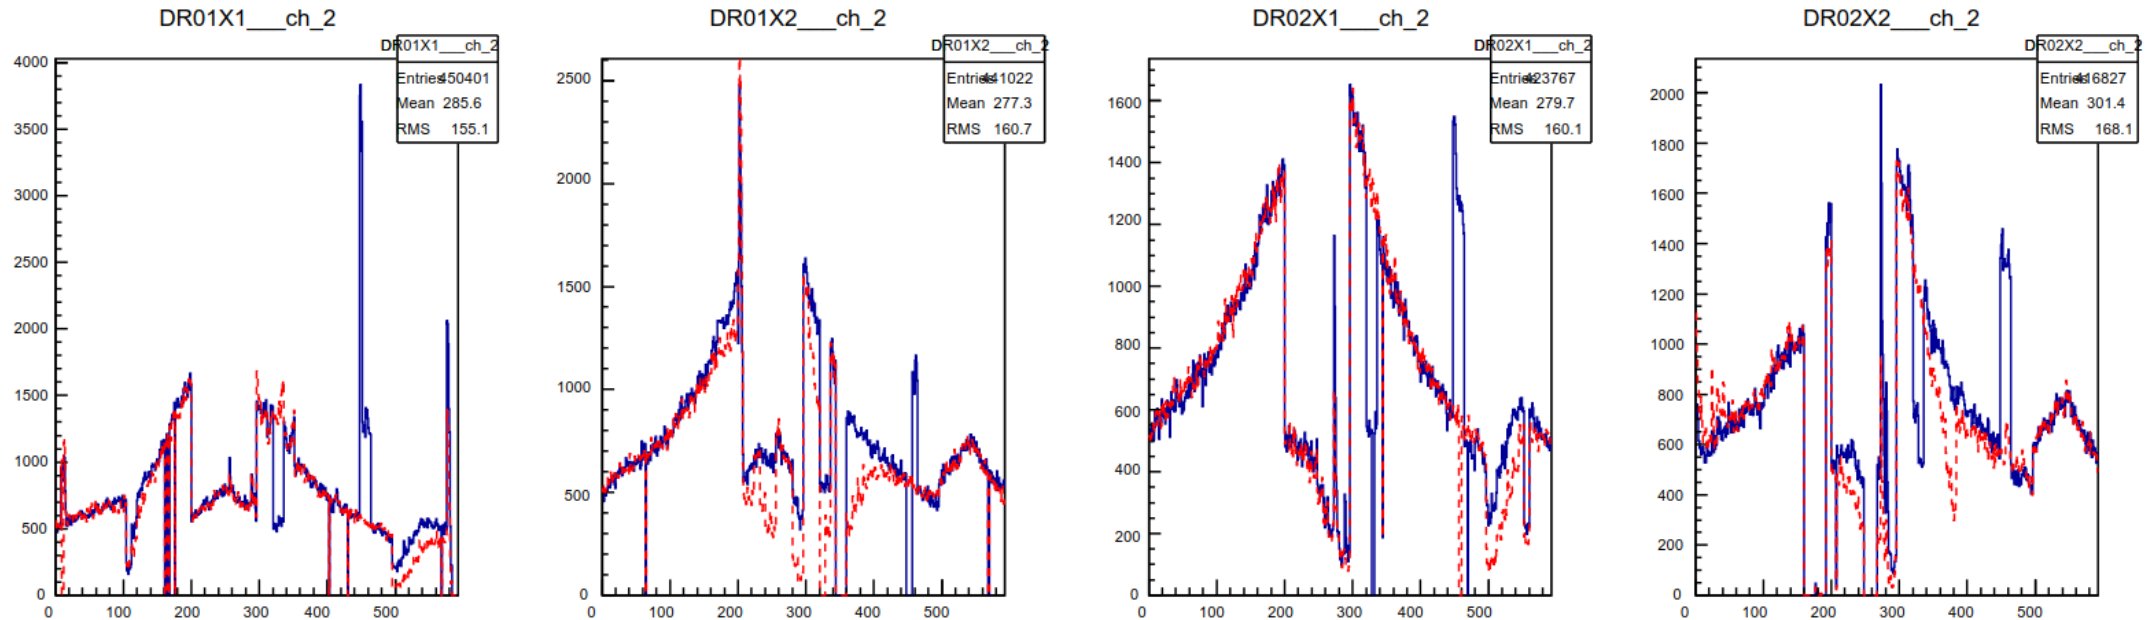
Richwall: some improvement

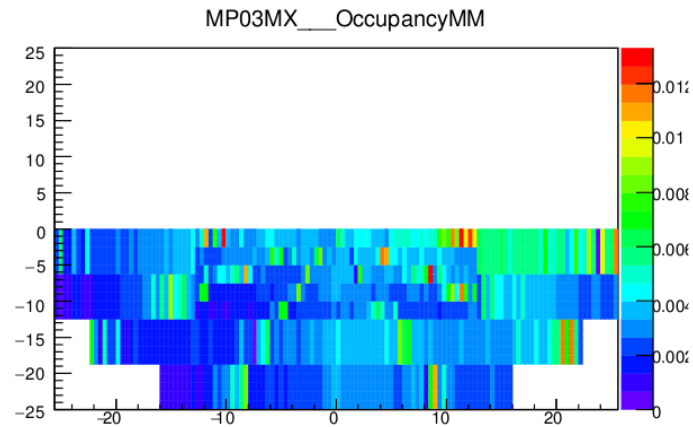
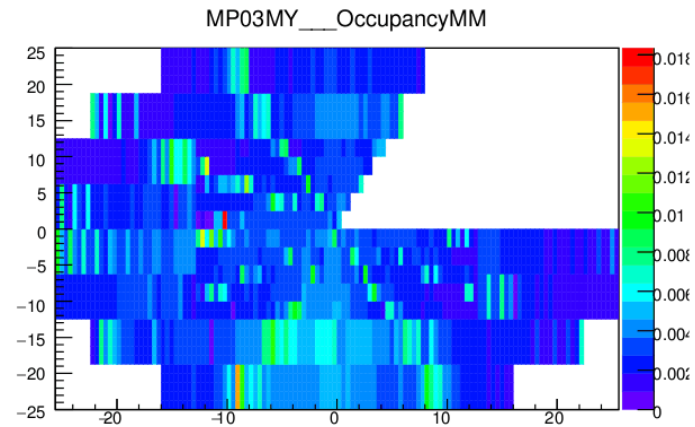
Histos

30.07. ~19:00 Lost part
pf PMM3 pixels

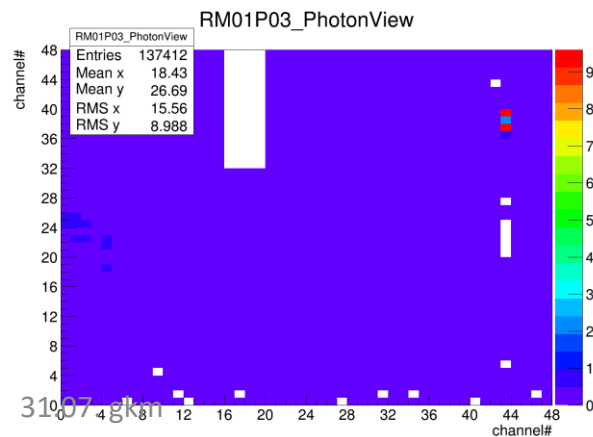
Rich hot channels,
at least since Friday

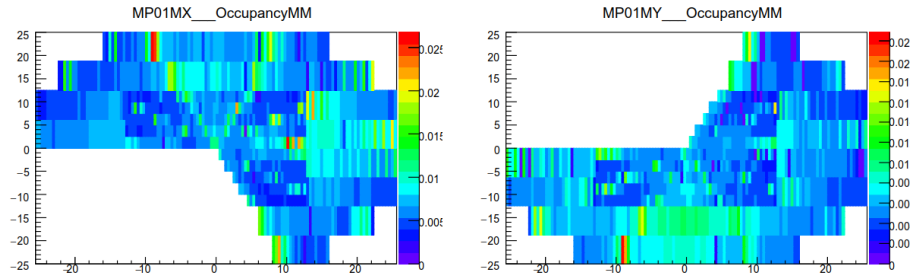
PMM 1

- PMM: MP01MX and MP01MY missing sectors, PMM3, SrcID 382, needed to reboot pccofe15 (Gesica) **persistent**
27.07, solved
- DC01X1: SrcID 256, miraculously solved 27.07, solved
- DC04: three ports missing DC04X1, DC04U1, DC04U2 all pretty central **persistent**
- RW: moderate inefficiencies, Maxim invest. gas flow **persistent**
- ECAL1: SrcIDs 627, 628, 629 off from Fri to Sat 11:00, fan-tray exchanged 28.07, solved
- PA05: noise **persistent**

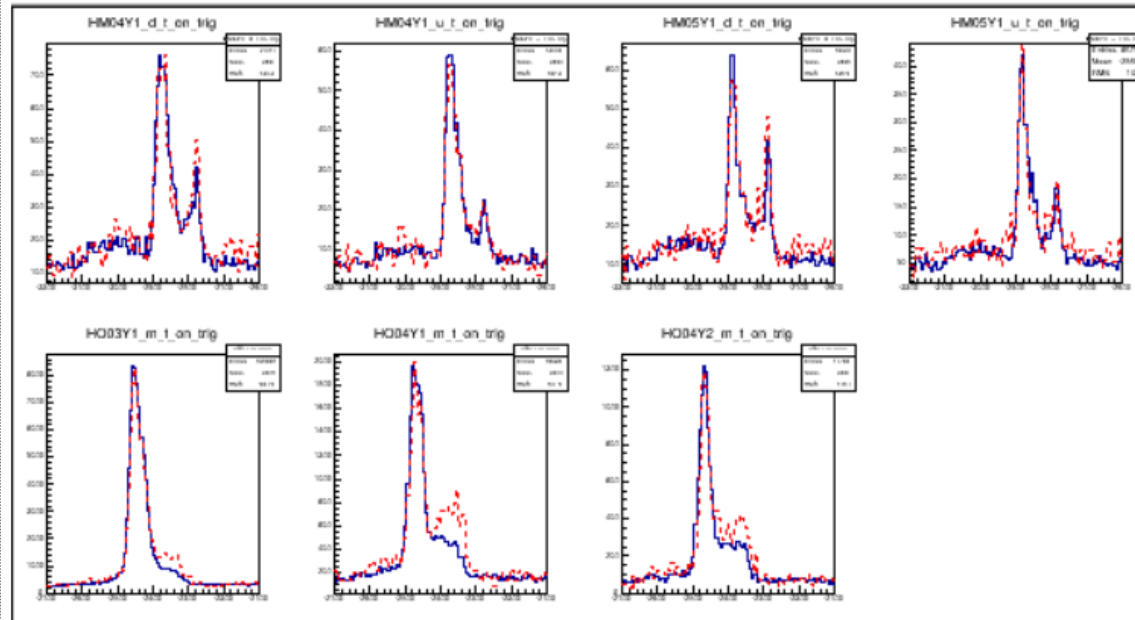
I replayed 8 chunks of run #284876 to investigate the problem.

=> The situation in HMs has not changed since reference.

=> Not the case in HOs, where the amplitude of the smaller has decreased...
