Weekly Report

DY 2018 run

June 22nd

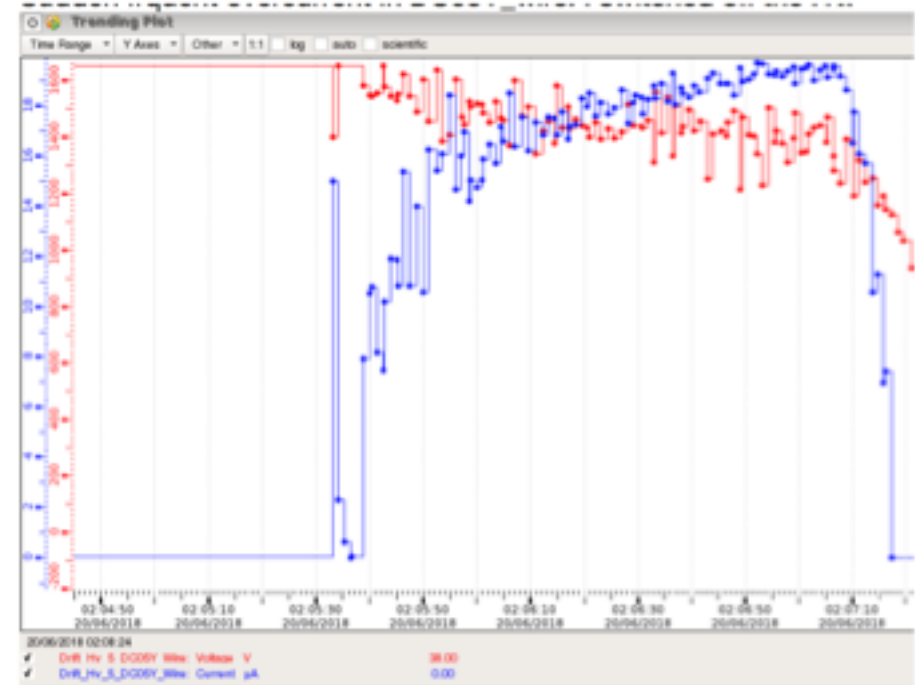
- Over current in DC5 wire (Wednesday night) :
- The voltage cannot be raised more than 400V for this channel;
- The problem has been identified to be inside the detector, Y' view is deactivated while Y view is properly working;
- The tension is back to nominal value on all other channels.

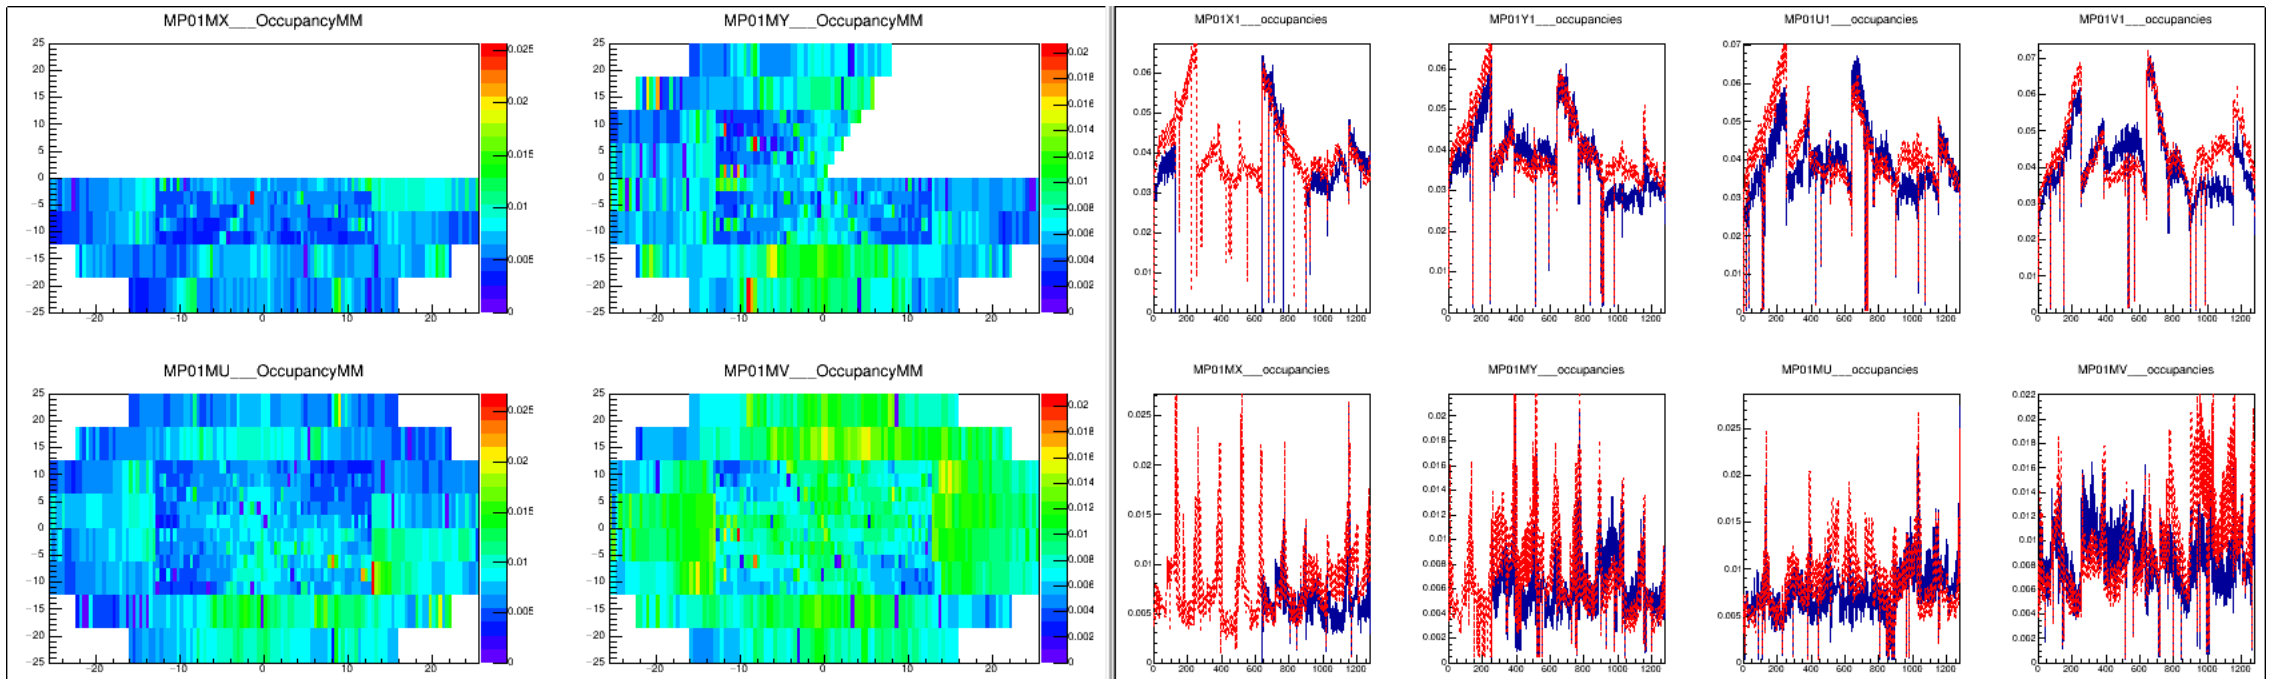
- One ADC missing, no way to get it back either reloading or powercycling it;
- Damien had to reinstall the main firmware of the ADC on Thursday;
- This problem is now solved.

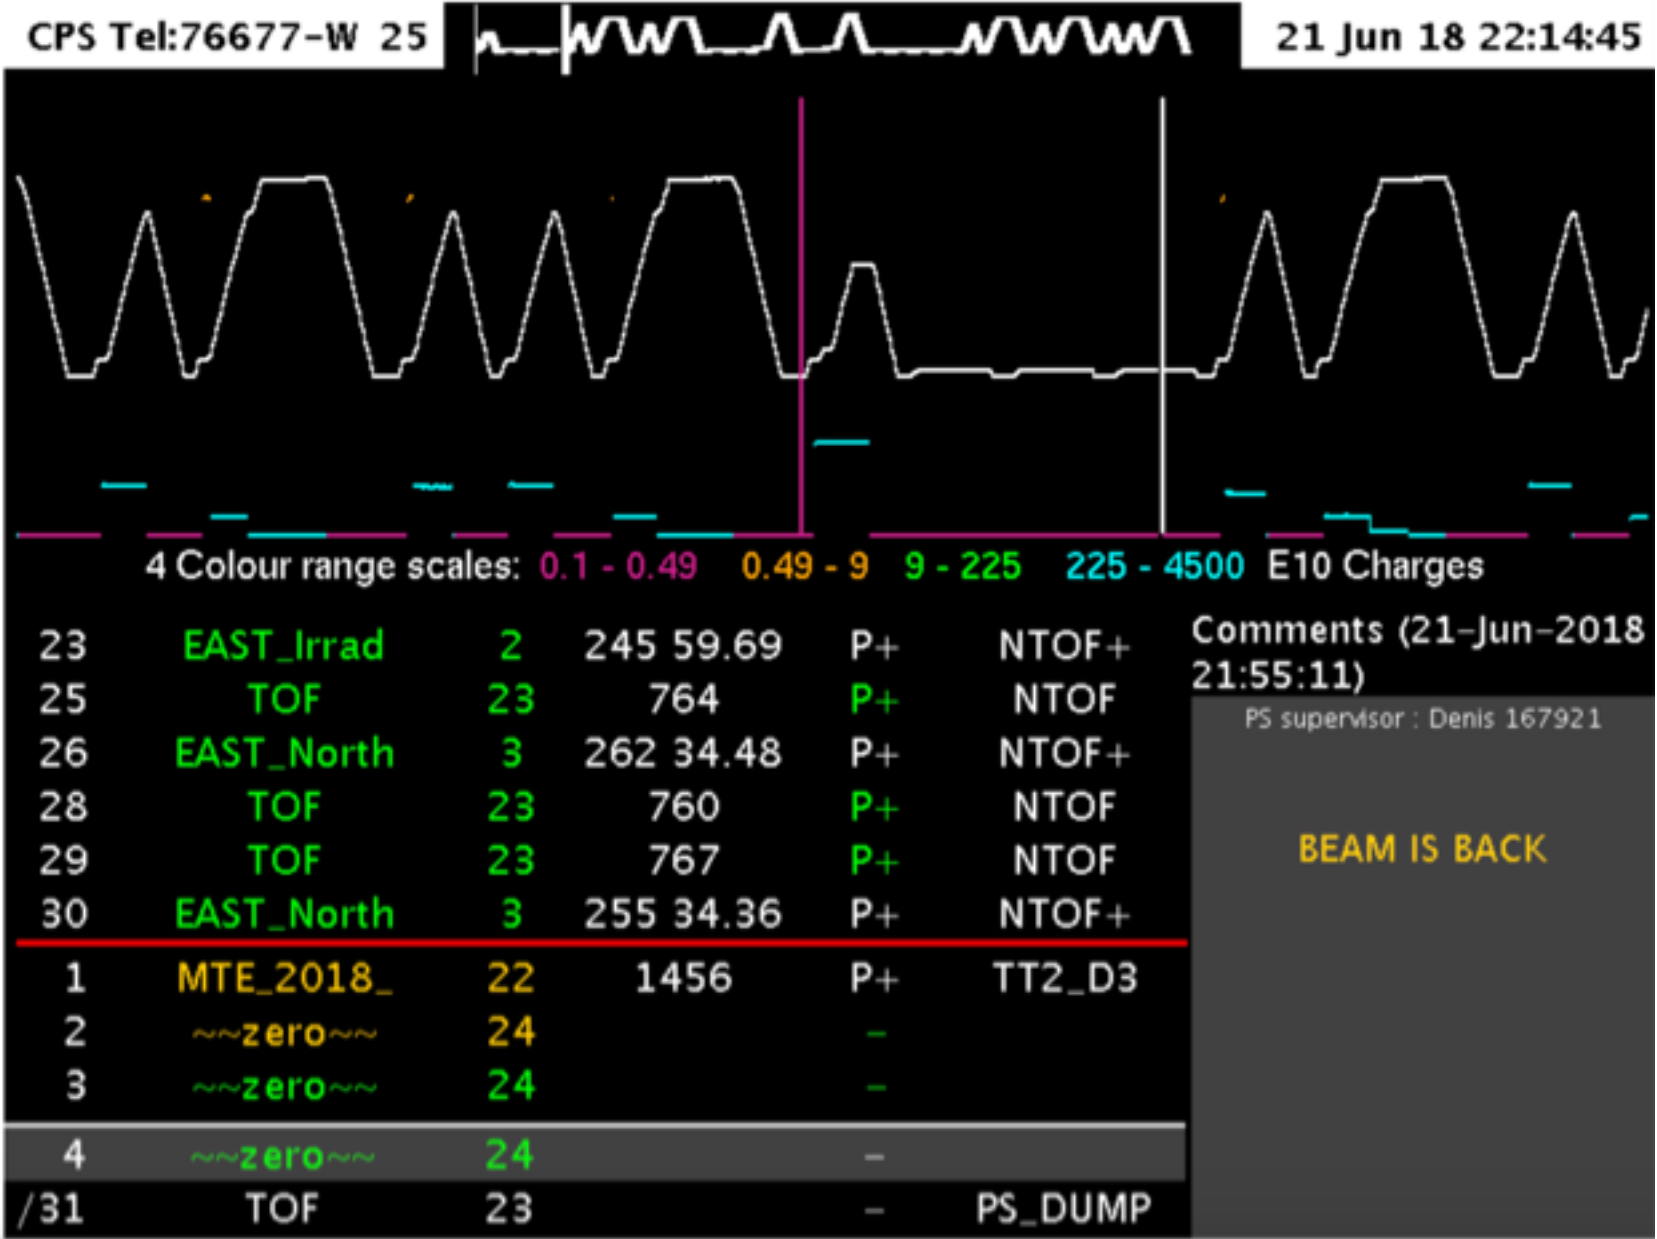
PS power system has an internal error.

Specialist is on site and working on it, but no firm time estimate now

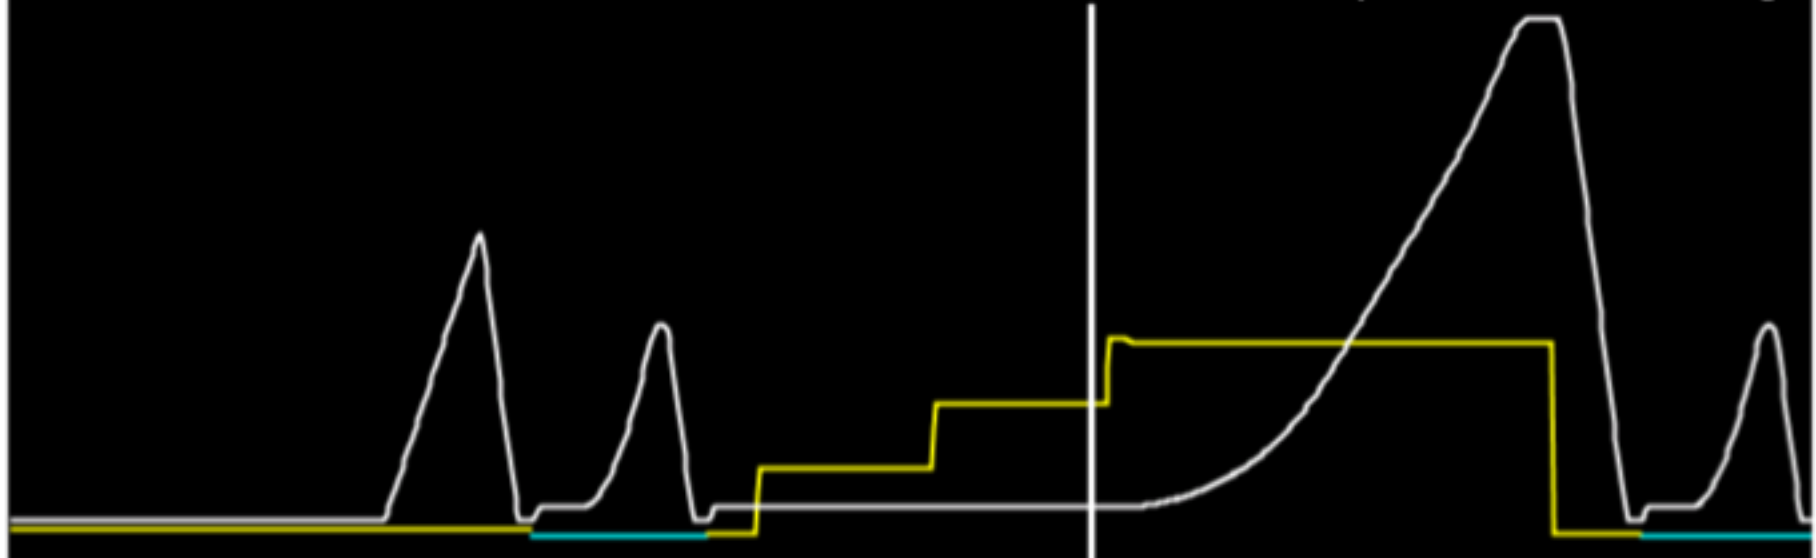
Power converter and magnet problems.
 Access required in BA80
 Magnet and RP piquets called.
 More news around 0:00

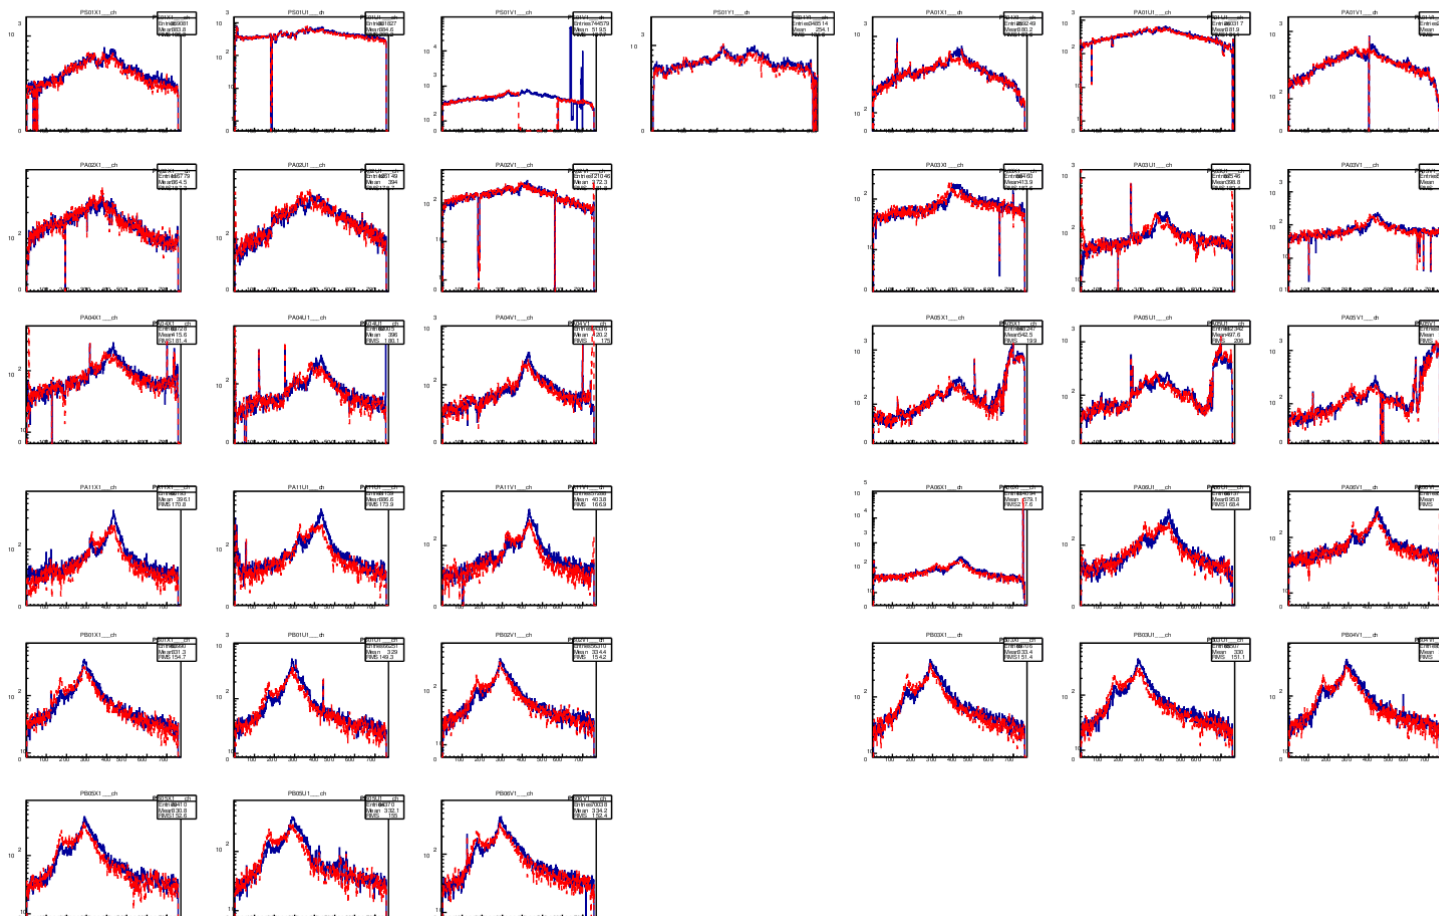
Run 283872 MWPC hits logy: MWPC_ch_logy.cfg - Page 1 (64100 evts) Fri Jun 22 08:17:44 2018

100% readout error on SrID 454 but no evident effect in cool plots ?
Reload does not have any effect...
