**WEEK 27-28**

**Weekly Report**

# COMPASS

**Weekly Meeting  
July 13, 2018**

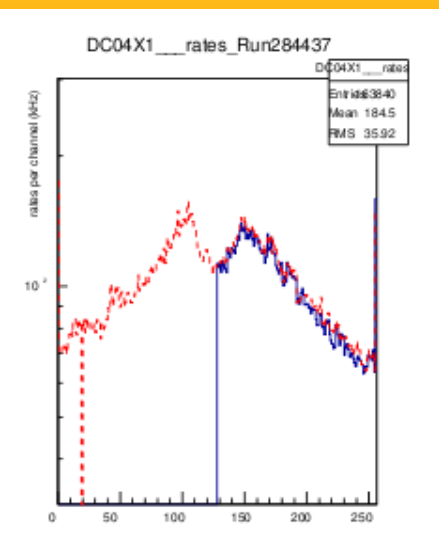
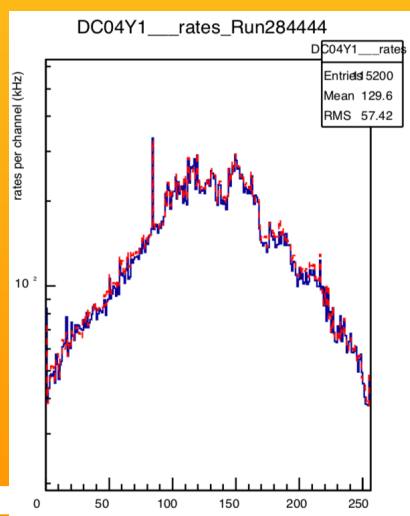
DC04Y1\_\_rates\_Run284395

DC04Y1 SrcID 259 port 7 (on Tue)

low efficiency part of profile. NO errors on MurthyTV. pccofe20 was reloaded. Seems no effect...recovered after about 2h

- Then I replaced the card **SrcID 259#7 (DC04Y1)**. This card was a MM spare card, replaced the previous week, which showed some instabilities. While going to the next step of the repair, it appears that **259#7 ethernet cable broke**

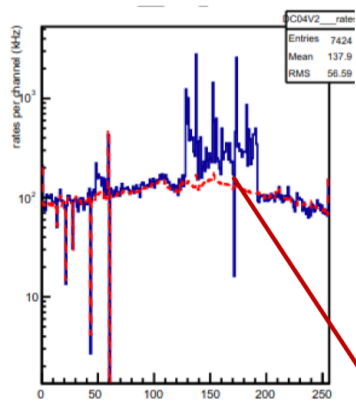
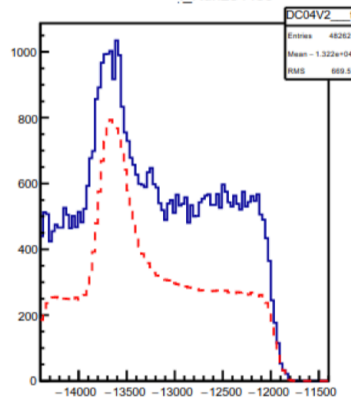
DC04V2 Rates

Threshold -0.9V One card very noisy

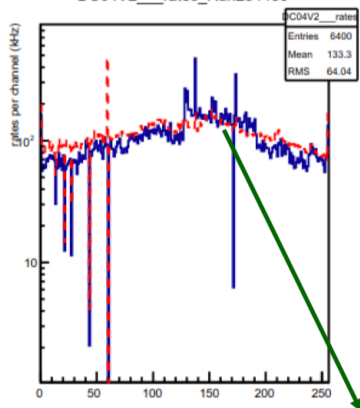
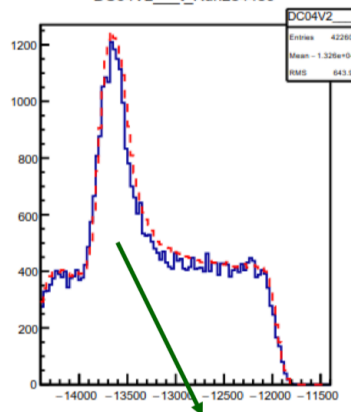
DC04V2\_\_rates\_Run284485

Threshold -1.2V Noise reduced, no reduction for time-correlated evts

- Threshold increase from -0.9V to -1.2V corresponds to a Gain drop of ~30% i.e. HV drop of ~30Volts i.e. RT shift (plot above) of 1.2ns
- From cool plot total nb of time-correlated evts looks unchanged (compared to reference, as expected from HV tuning -> 100V above beginning of efficiency\_plateau)
- We propose to set DC04V2 threshold to -1.2V

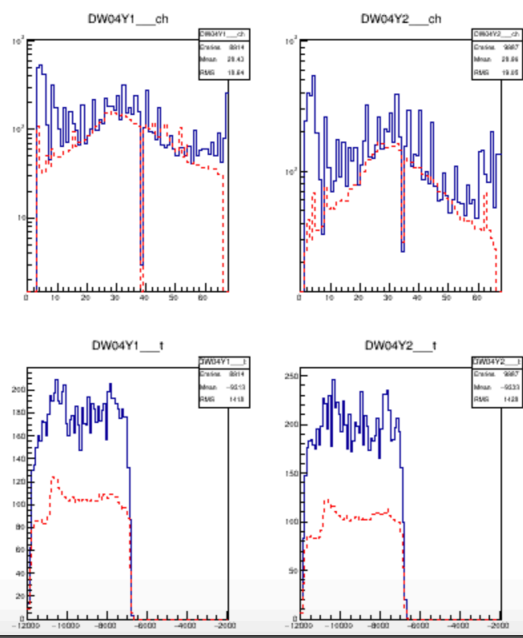
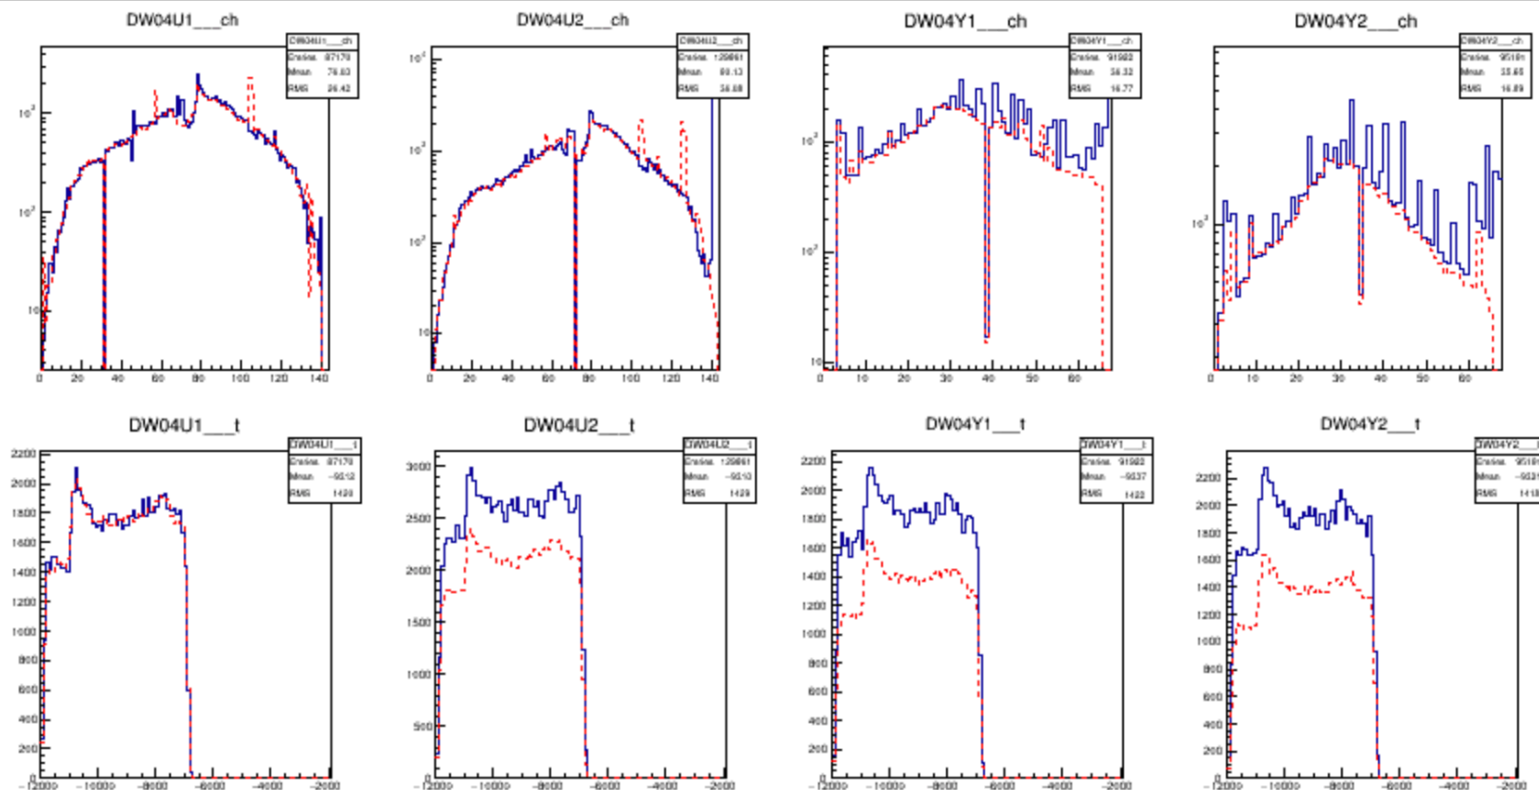
### Noisy planes: DW04 U2 Y1 and Y2 appearing

During the MD yesterday, I tightened the screws of the grounding connections, plugged the LV cables from card #2 on different pins on the black rail to reduce cable tension, exchanged the MAD4 cards #3,1 and #3,3 and put a little extra copper foil on them.
