Friday 21.09 - Friday 28.09

Weekly report

Nikolay Anfimov, Week coordinator, JINR.

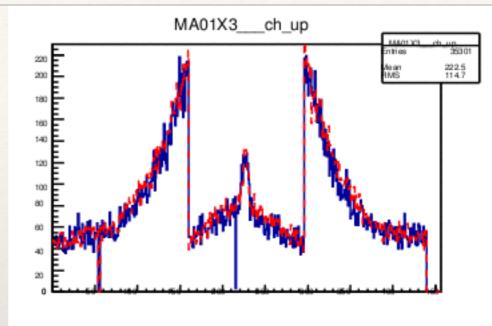
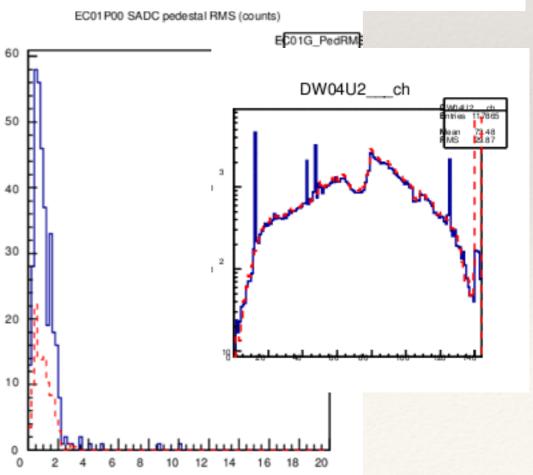
Friday 21.09.Day

- * W45: DW04U2 and DW05V2 increase noise in few channels. Expert is aware
- * MW1: MA01X3 one channel down and MA01Y4 some noise channels. Expert is aware
- * ECAL1: EC01P00, EC01P01, EC01P02 pedestals look different. Expert is aware
- * Bend9 was OFF for 40min. It was recovered by Michael.
- * Beam lack: PS Pole Face Windings problem

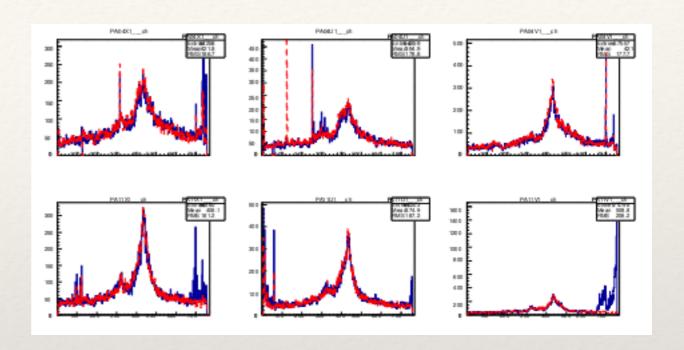
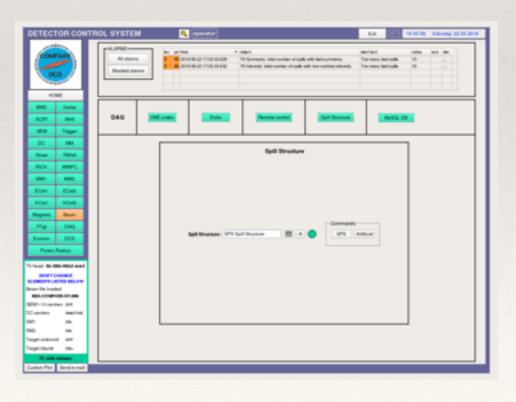
Saturday 22.09. Evening

- No beam since 5 pm till 7:30 pm
- * A few noisy channels on MWPC. I ask the expert to prepare instructions (scripts etc).
- Christof added DCS Spill structure alarm. If no access, an alarm will be triggered after 5 minutes in artificial spill structure.
- * ECAL2 too many bad blocks. Issue immediately had gone.

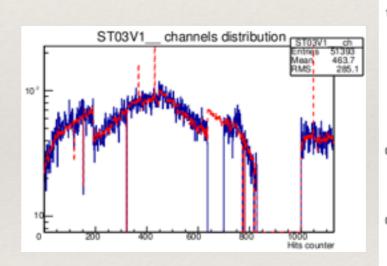
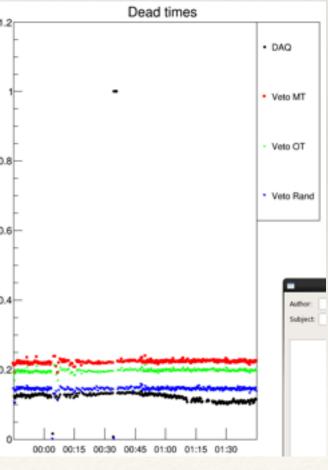
Saturday-Sunday 23.09. Night

- * Minor beam instabilities.
- Noisy channels on MWPC.
- * Straw03V1 card missing. It was resolved.
- * DAQ dead time was going down. Why? Sent message to Vladimir.

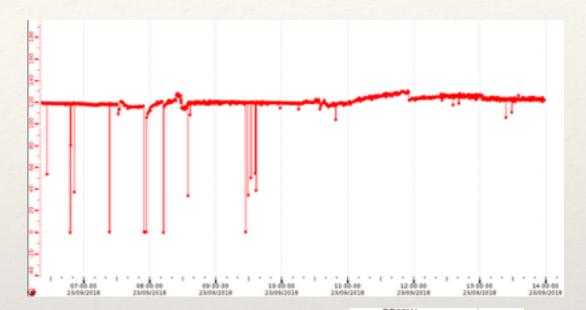
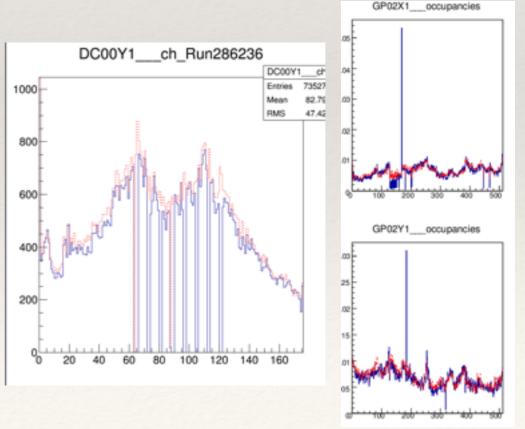
Sunday 23.09. Day

- * Minor beam instabilities. Shifters thoroughly the care of intensity.
- Noisy channels on MWPC. Expert will act after daily meeting.
- * SID 247 generate errors. LOAD -A didn't help. Expert resolved.
- Straw 324 port11 errors in card ST03U1. Expert suggested to restart PCCOFE13
- * DC00Y1 with missing channels, partially recovered with help of Vincent.
- * Spikes in GEM occupancies (GP02X1 and GP02Y1). Expert is aware. She reloaded the equipment.
- * DC04 HV issue. Reload didn't help. Vincent did crate power cycle in the area.
- Number of Good Spills > 3849 (3933)

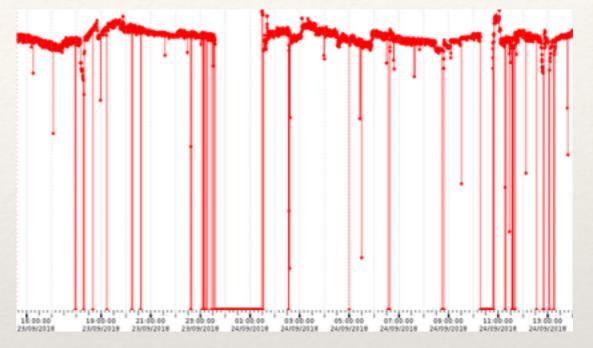
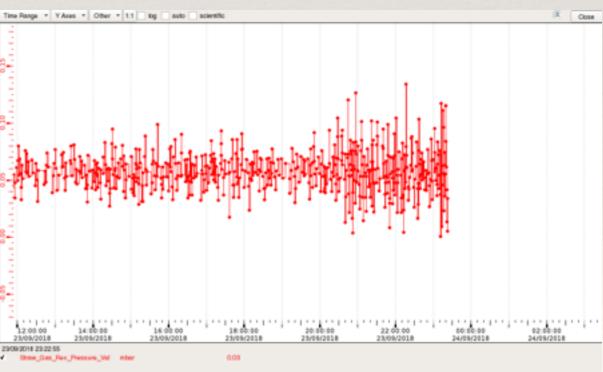
Sunday 23.09. Evening

- * Beam was absent for 1,5 hours after 11 pm
- * DC 04: Access to power-cycle the crate solved the problem. Vincent
- * MWPC: Power-cycling PA03, PA05, PA11.

Trying to recover the noise, we got lost port 4 of SrcID 452. Vincent could manage to fix it during short access by touching hotlink connector from CATCH side. It didn't help from noise
- * STRAW: Straw pressure from REX valve alarm. Got an alarm from the REX valve reading indicating that it's too low. The trending plot was checked and is can be observed that pressure has shown larger variation in the last few hours. The alarm is gone now and we don't think it is really critical

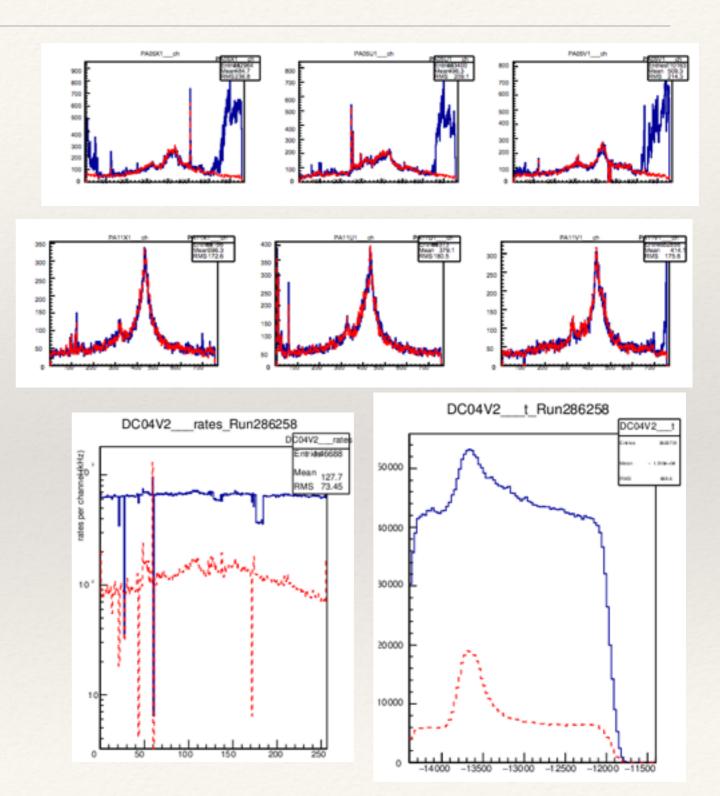
Sunday-Monday 24.09. Night

- * MWPC is noisy.
- * DC: threshold catd of DC00-01 lost communication with DCS. Since no consequences can be seen in coool plots, lnxpool25 will be restarted in the next period without beam.
- * DC: lnxpool25 was rebooted
- DC04V2 lost thresholds?

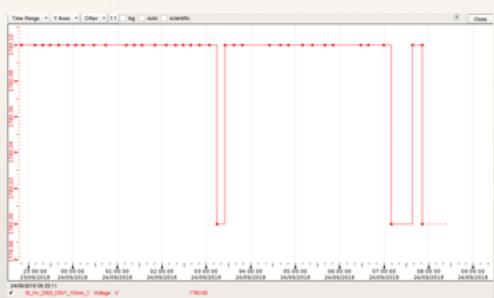
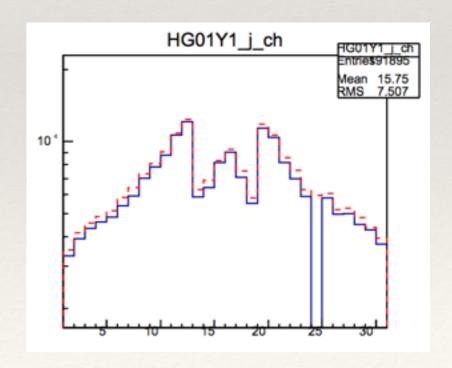
Monday 24.09. Day

- * STRAW: HV channel St_HV_DI02_03V1_10mm_1 is tripping often.
- * DAQ: PCCORC35 got stuck (very often!)
- Hodoscopes: HG01Y1 channels missing
- MM: Shifter informed that there were errors on all PMMs, including SrcID 380, 381, and 382, and tried to reload it, but it didn't work. I did a powercycle on the corresponding LVs, needed to do twice on SrcID 381, and things are back to work again.
- * RW: SID 432 have to be reloaded.

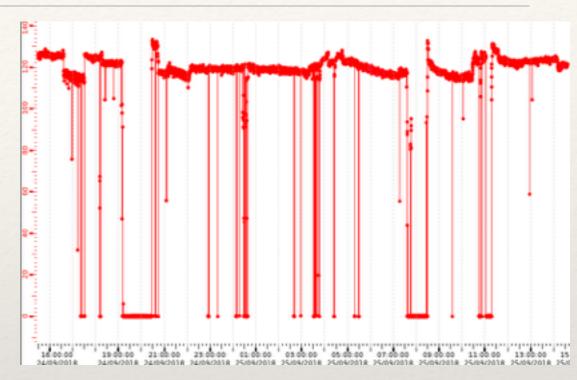
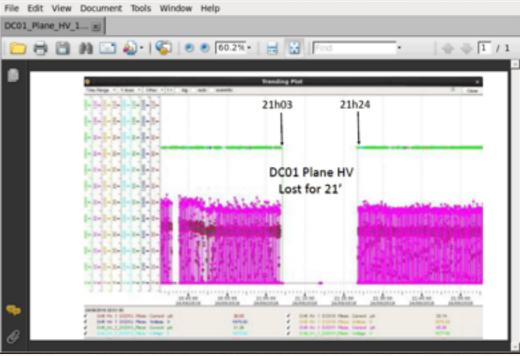
Monday 24.09. Evening

- Beam was absent for 1,5 hour
- * MM: MP02MX Noise. PowerCycle and reload SIDs.
- DC00(01): Alain. I tried DC00(01) LV power cycle, then LOAD -A 256/257/258 a few times. I also reapplied the thresholds on DC00Y1. Unfortunately, NO effect. Vincent is strictly against to make insufficient things during beam time!
- At ~21h04min, SM1 network switch got stuck. It was stopped and restarted from the DCS
- * At ~21h18min, the HV channels of DC0, DC4 and DC5 went off. They were switched back on via the DCS. Alain link it to SM1 network switch issue. Vincent: The HV for DC01 was not lost, only the communication was affected due to the network switch. Reason why there is no HV ramp-up. In principle datataking could have continued. HV for DC00/04/05 is not correlated with the network switch.

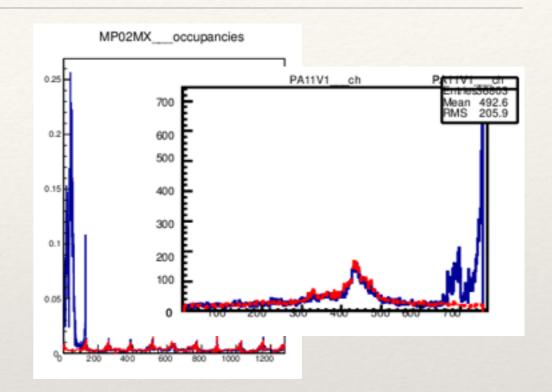
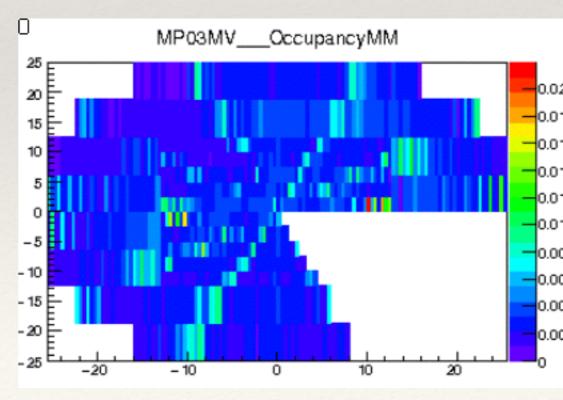
Monday-Tuesday 25.09. Night

- * Beam lack for 1 hour at the end of shift
- * MM: the same plane MP02MX. Reload helped.
- * MWPC: PA11V1 plane. Reload didn't help
- * Hodoscopes: HG01Y1_j lost one channel
- ECAL2: LED monitoring of ECAL2: too many bad blocks
- * Pixel MM: Loss of one part of MP03MV towards end of run #286284. Reload SID 382 helped.
- * DIP 7 alarm: CEDAR1 and 2 do not send heart beat to DIP Manager. Christophe and then CCC were called. CCC rebooted DIP gateway NORTH. But communication is still absent. Christophe made the ticket and masked the alarm. Was solved and unmasked.
- * RW: 100% errors in MurphyTV on RW 432 port 0 GeoID 5 A reload after the run fixed the problems on the Y-plane of RW

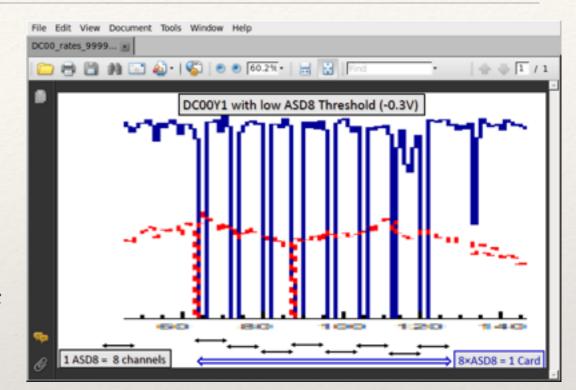
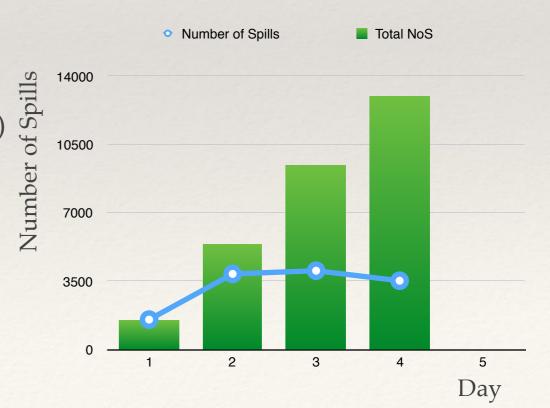
Tuesday 25.09.Day

- Beam back at 8:30
- * DAQ: A lot of errors on DC05 (about 88%), on ST03 (about 30%), Gandalf (33%) and 1007-Straw-multiplexer (about 17%) and pccotg03 was not reachable.
 - Surprisingly, LaCamera was also giving about 20% of errors on MurphyTV (.... from clean area)!
 Suspicion: problem on MUX12 or tiger. Access to the area and Power-cycle of VXS and unpluging/repluging pccofe52 solved all the problems.
- * DC00Y1 missing channels. Alain tried (during access) to setup different thresholds. It is independent on it. May be broken discriminator channels (contacts)?

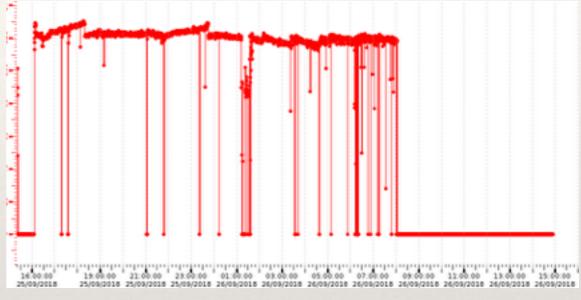
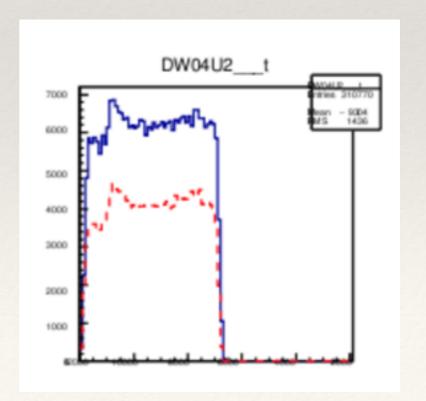
Tuesday 25.09. Evening

- * DCS-RW: There was an error notification in DCS about CAEN1 OPC Manager (RED) where the RICH WALL VME with IP (172.22.24.31) lost communication. The same crate triggered an error in DAQ for DAQ_VME_RWALL (Orange). Powercycle the create (MD)
- * W45: Some noisy plane in bookies
- DAQ: stopped due to desynchronization of DAQ mismatch between layers

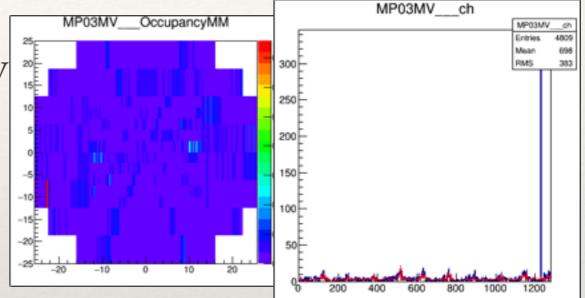
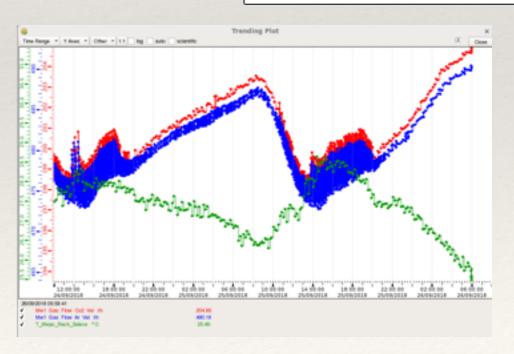
Tuesday-Wednesday 26.09. Night

- * Pixel MM: Noise on PMM (MP03MV). Noise on MP03MV can not be cured by reloading
- DAQ: PCI/DMA error occured after a sequence of DAQ crashes (safe stops)
- * RW: Argon gas flow alarm. The temperature drop during the night led to an increased gas flow. However, the gas mixture remains constant, therefore no action is required. Annika was informed.

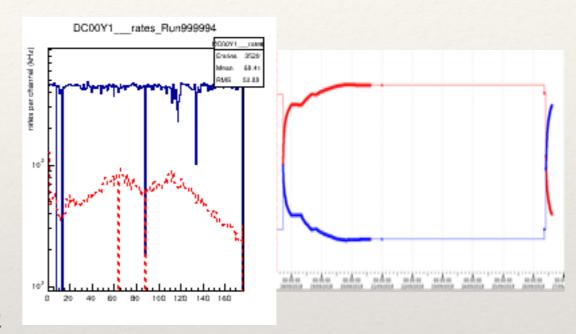
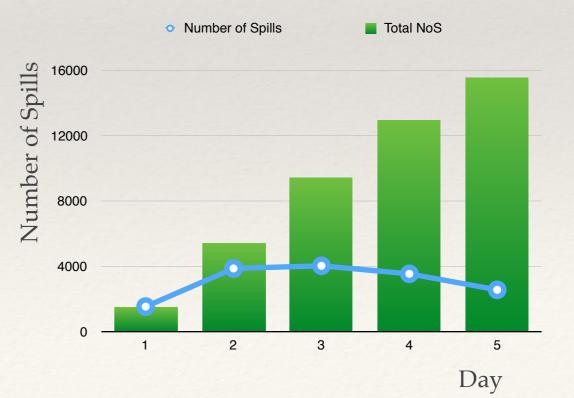
Wednesday 26.09.Day

- * DC: Recovery of DC00Y1. Damien suggested the problem could be related either to a corrupted firmware (need to exchange the card) or to a bad connection catch <-> F1

Vincent. The loading would be partially done and some channels on the F1 would be left disable -> therefore no MurphyTV errors.

We cleaned the hotlink on the catch side and recovered the missing channels.
- * Christophe power-cycle RW create. Unmask in DCS. Reload SID432
- * Target repolarization. Refilling material dewars and check water level of NMR cooling.
- * ECAL2: Change HV bases in Ecal2
- * DAQ: Matous. Cable labeling ~ 30 min
- CEDARs: Thresholds settings. Disabled from DAQ
- * Annika. Excursion to the area.
 - Total Number of Good Spills > 15000

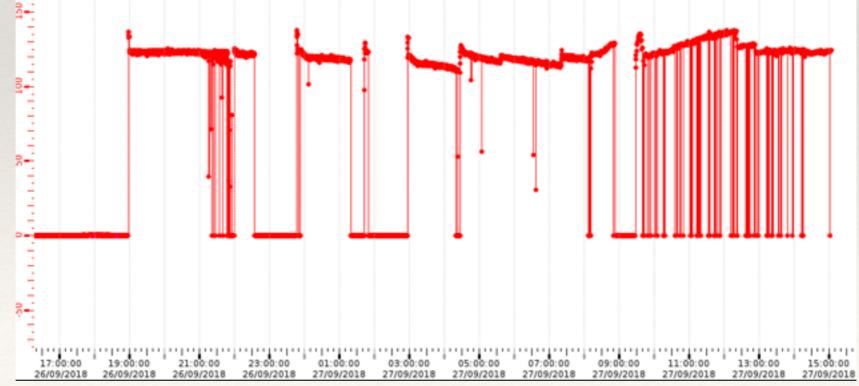
Wednesday 26.09. Evening

- Beam came back around 7 pm
- * Data Recording: Vladimir. 18W16 has started since 286325. All 55418 data files were copied to castor successfully!
- * CEDARs: DIP 7 alarm. Vincent contacted to CCC operator and they reset the VME.
- * DC: Alain. DC00Y1 also DC00Y2 thresholds were set to low value to check readout. They are ok!

* Target: Michael. Stop DNP. Still to 6V. Polarization -56% upstream and +68.8% downstream. Go to dipole field.

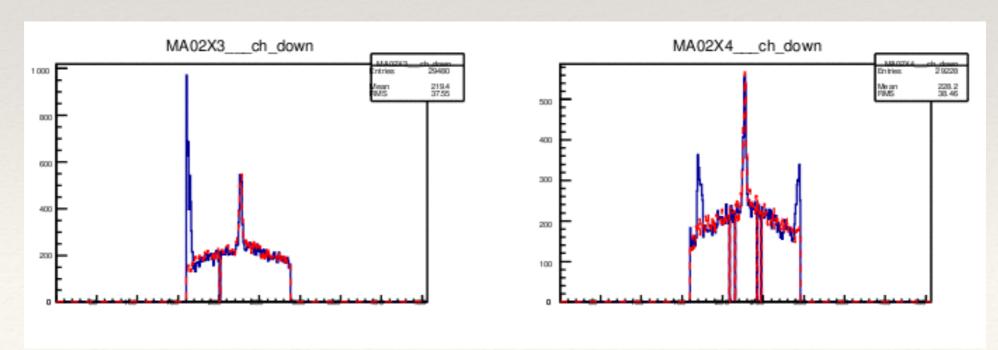
Wednesday-Thursday 27.09. Night

- * STRAW: Trip St_Hv_Dl07_03Y1_10mm_1
- MW1: Noisy channels MA02X3__ch_down and MA02X4__ch_down. Expert is aware and issue had gone.
- * DAQ: Run number was not incremented! for run 286334 the run number was not incremented after the end of run. Therefore a 200-spill run is missing in the run database. However, the data are in the /cdr directory. But it might be that these data have duplicate spill and event numbers. This should be checked by the experts!!! Antonin is investigating this incident. 400 spills were stored into 1 file. Vladimir is also aware.

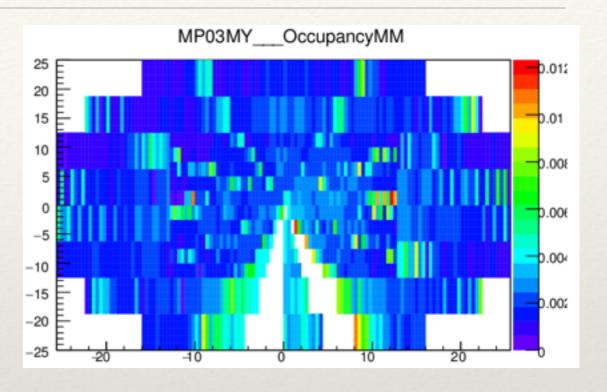
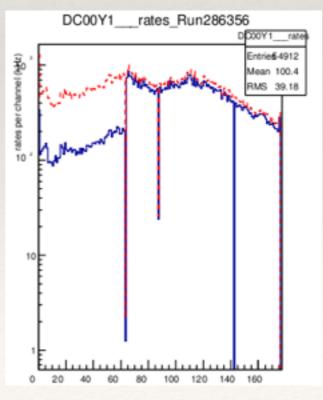
Thursday-Friday 28.09. Night

- * MM: Missing part on MP03, recoverd by reloading SrcID 382
- * DC: Low rate of a part of DC00Y1, solved by reloading SrcID 257
