**WEEK 27-28**

**Weekly Report**

# COMPASS

**Weekly Meeting  
July 13, 2018**

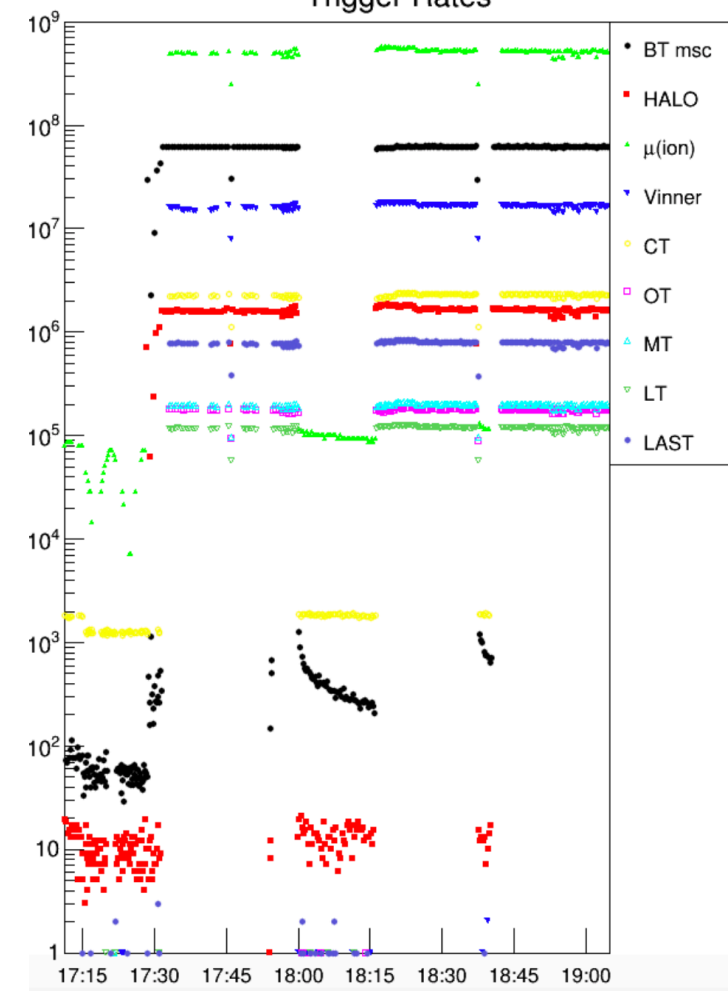
Mon Jul 9 19:05:01 2018  
Trigger Rates

12:00 - 17:00 No beam  
- Syncro problem between PSB and SPS (kicker trip)  
- RF cavity power distribution off

15:00 - 17:00 No beam  
"Intervention required in PSB"  
Then unstable beam until around 23

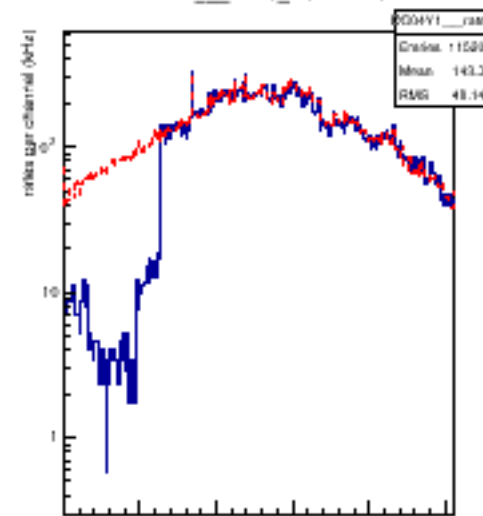
DC04Y1\_\_rates\_Run284395

DC04Y1 SrcID 259 port 7 (on Tue)

low efficiency part of profile. NO errors on MurthyTV. pccofe20 was reloaded. Seems no effect...recovered after about 2h

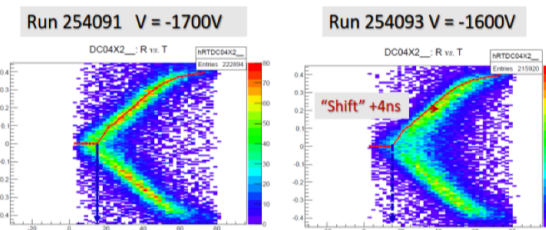
DC04X, "shift" of RT relations vs HV

Saclay DC04  
=> TB 150204

RT "shift" is +4ns for -100V => Gain ÷2

- Threshold increase from -0.9V to -1.2V corresponds to a Gain drop of ~30% i.e. HV drop of ~30Volts i.e. RT shift (plot above) of 1.2ns
- From cool plot total nb of time-correlated evts looks unchanged (compared to reference, as expected from HV tuning -> 100V above beginning of efficiency\_plateau)
- We propose to set DC04V2 threshold to -1.2V
